Manhole Inspection Summary

Manhole # S21M__036MH

Insp Date: **2/25/09 9:38 AM**

Location Address: **518 MONROE-ADDISON-ALLEY**

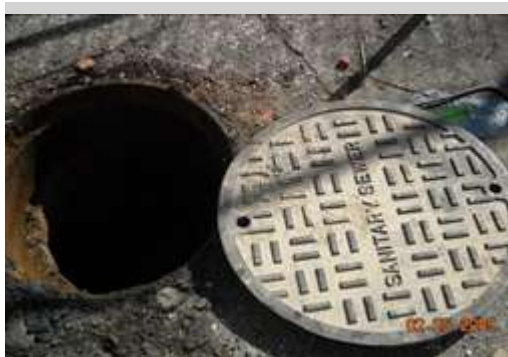
MISC.

Comments **BROKE AND REPLACED COVER (see photos); POSSIBLE POINT OF ENTRY FOR
AUTOMOTIVE RUN OFF FROM ADDRESS 501 S MONROE ST**

REPLACED BROKEN COVER

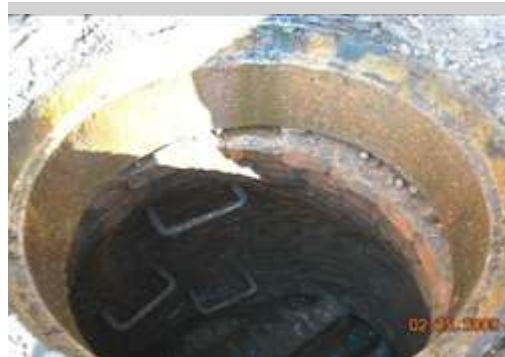
MISC.

INFLOW EVIDENCE FROM SHEETING

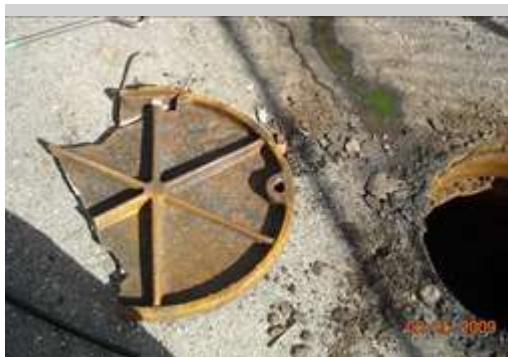
MISC.

BROKE COVER TO GAIN ACCESS

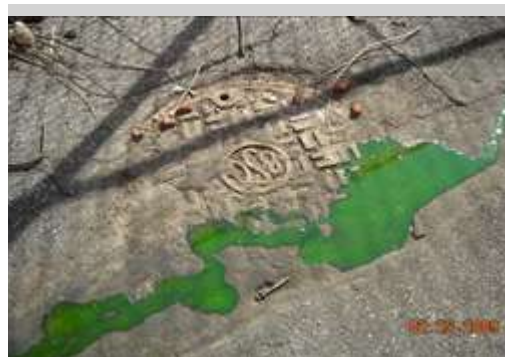
MISC.

ENCrustation of Manhole Frame and Cover from Automotive Run Off

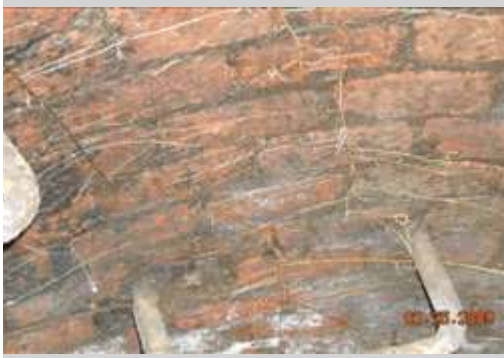
Defect 6

☒ **Root Intrusion**

ROOT INTRUSION @ BARREL WALL

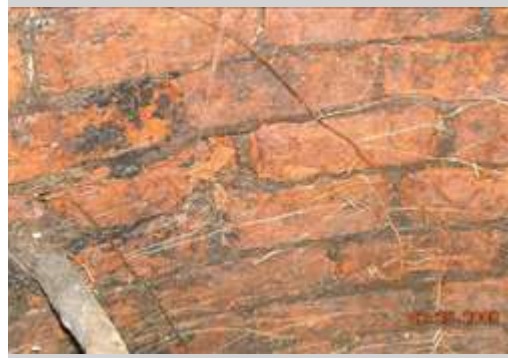
Defect 5

☒ **Cracked**

CRACKED BARREL BRICKS

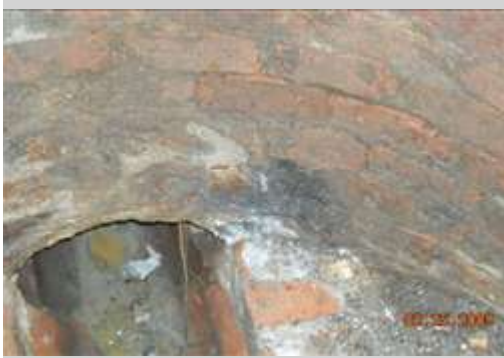
Defect 4

☒ **Wall**

INFILTRATION EVIDENCE @ BARREL WALL

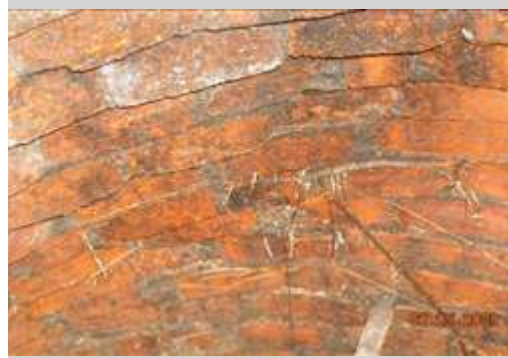
Defect 3

☒ **Root Intrusion**

ROOT INTRUSION @ CORBEL WALL

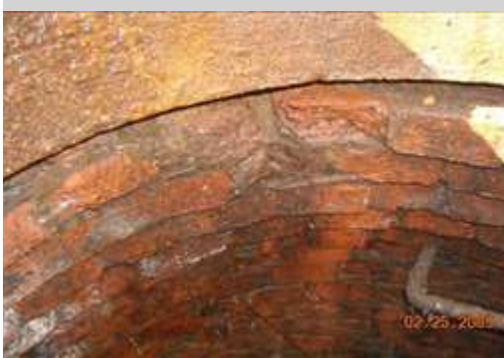
Defect 2

☒ **Deteriorated**

☒ **Wall**

infiltration & DETERIORATED CORBEL BRICKS

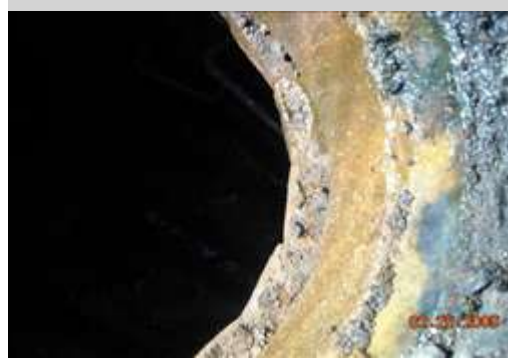
Defect 1

Offset: **1.5** (in.)

☒ **Leaks**

FRAME OFFSET & leaks

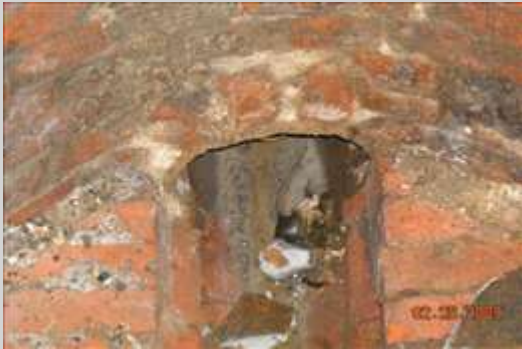
12 O'Clock Outflow

8 in. Circular Gravity Sewer
Pipe Out @ 12 O'Clock

Pipe Height: **8.4** (in.) Rod and Bar (Angled)
Pipe Material: **Clay** ☐ Pipe Lined
Invert Depth: **6.25** (ft.) Flow Characteristics: **Slow**
Deposits: ☐ None ☐ Mud ☐ Sludge ☒ **Debris** ☐ Grease
Silt Depth: **1** (in.) Deposits Extent: **Light**
Infiltration: **None** Pipe Seal Cond: **Sound**

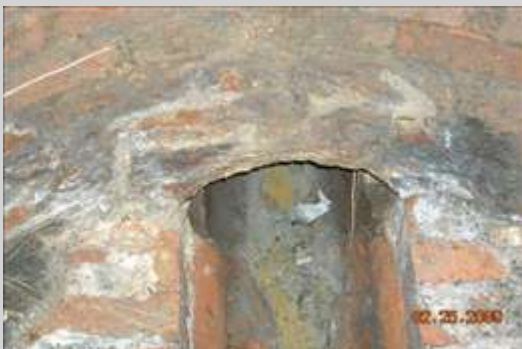
6 O'Clock Inflow

8 in. Circular Gravity Sewer
Pipe In @ 6 O'Clock

Pipe Height: **8.4** (in.) Rod and Bar (Angled)
Pipe Material: **Clay** ☐ Pipe Lined
Invert Depth: **6.15** (ft.) Flow Characteristics: **Slow**
Deposits: ☒ **None** ☐ Mud ☐ Sludge ☐ Debris ☐ Grease
Silt Depth: **0** (in.) Deposits Extent:
Infiltration: **None** Pipe Seal Cond: **Sound**
